Manhole Inspection Summary

Manhole # S33GG1019MH

Insp Date: **5/31/07 9:25 AM**

Location Address: **8 39TH ST**

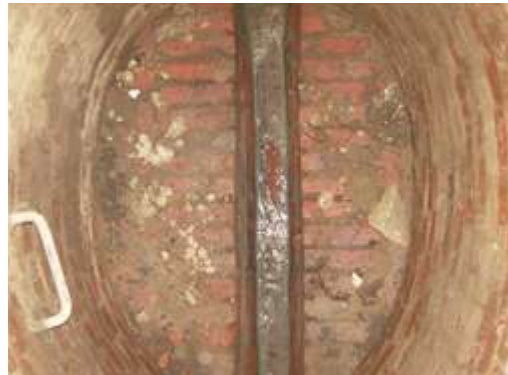
Top View

Bench ☒ Exists Material: **Brick** ☐ Parged ☒ **Debris** (not Condition related)

Surcharge ☒ **Evidence Of Surcharge** Depth: **1** (ft.) ☐ Active Surcharge Present

Evidence of surcharge - Bench debris.

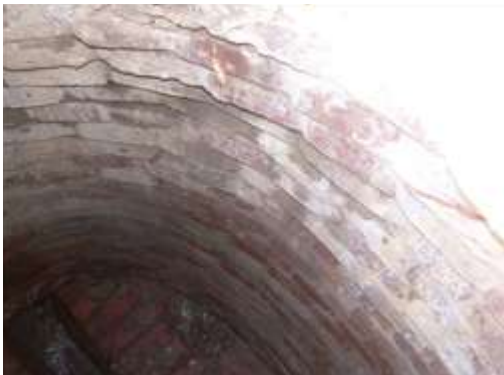
Defect

Condition: ☐ Sound ☐ Cracked ☐ Root Intrusion ☐ Loose Brick ☒ **Deteriorated**

Infiltration: ☐ None ☒ **Joint** ☐ Cracks ☐ Mortar ☐ Roots ☒ **Wall**

Corbel deterioration and infiltration. Barrel infiltration.

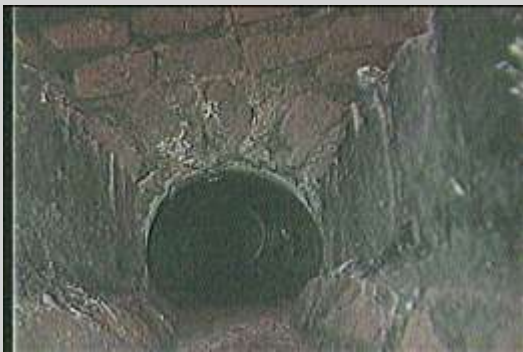
8 in. Circular Gravity Sewer Pipe Out @ 12 O'Clock

Barrel deterioration and infiltration. Channel deterioration.

Infiltration: **Evidence** Pipe Seal Cond: **Cracked**

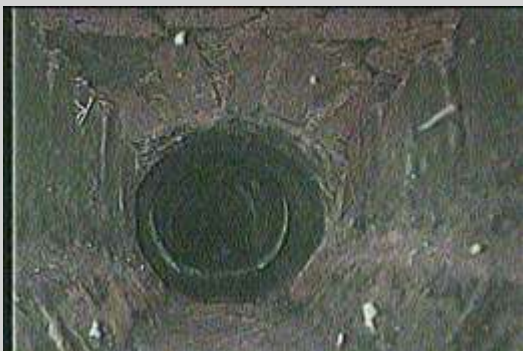
8 in. Circular Gravity Sewer Pipe In @ 6 O'Clock

Infiltration: **Evidence** Pipe Seal Cond: **Cracked**
